Entrapment in Garage Kills One Firefighter

San Francisco, California

USFA-TR-084/March 1995

**75 Everson Street
San Francisco, California**

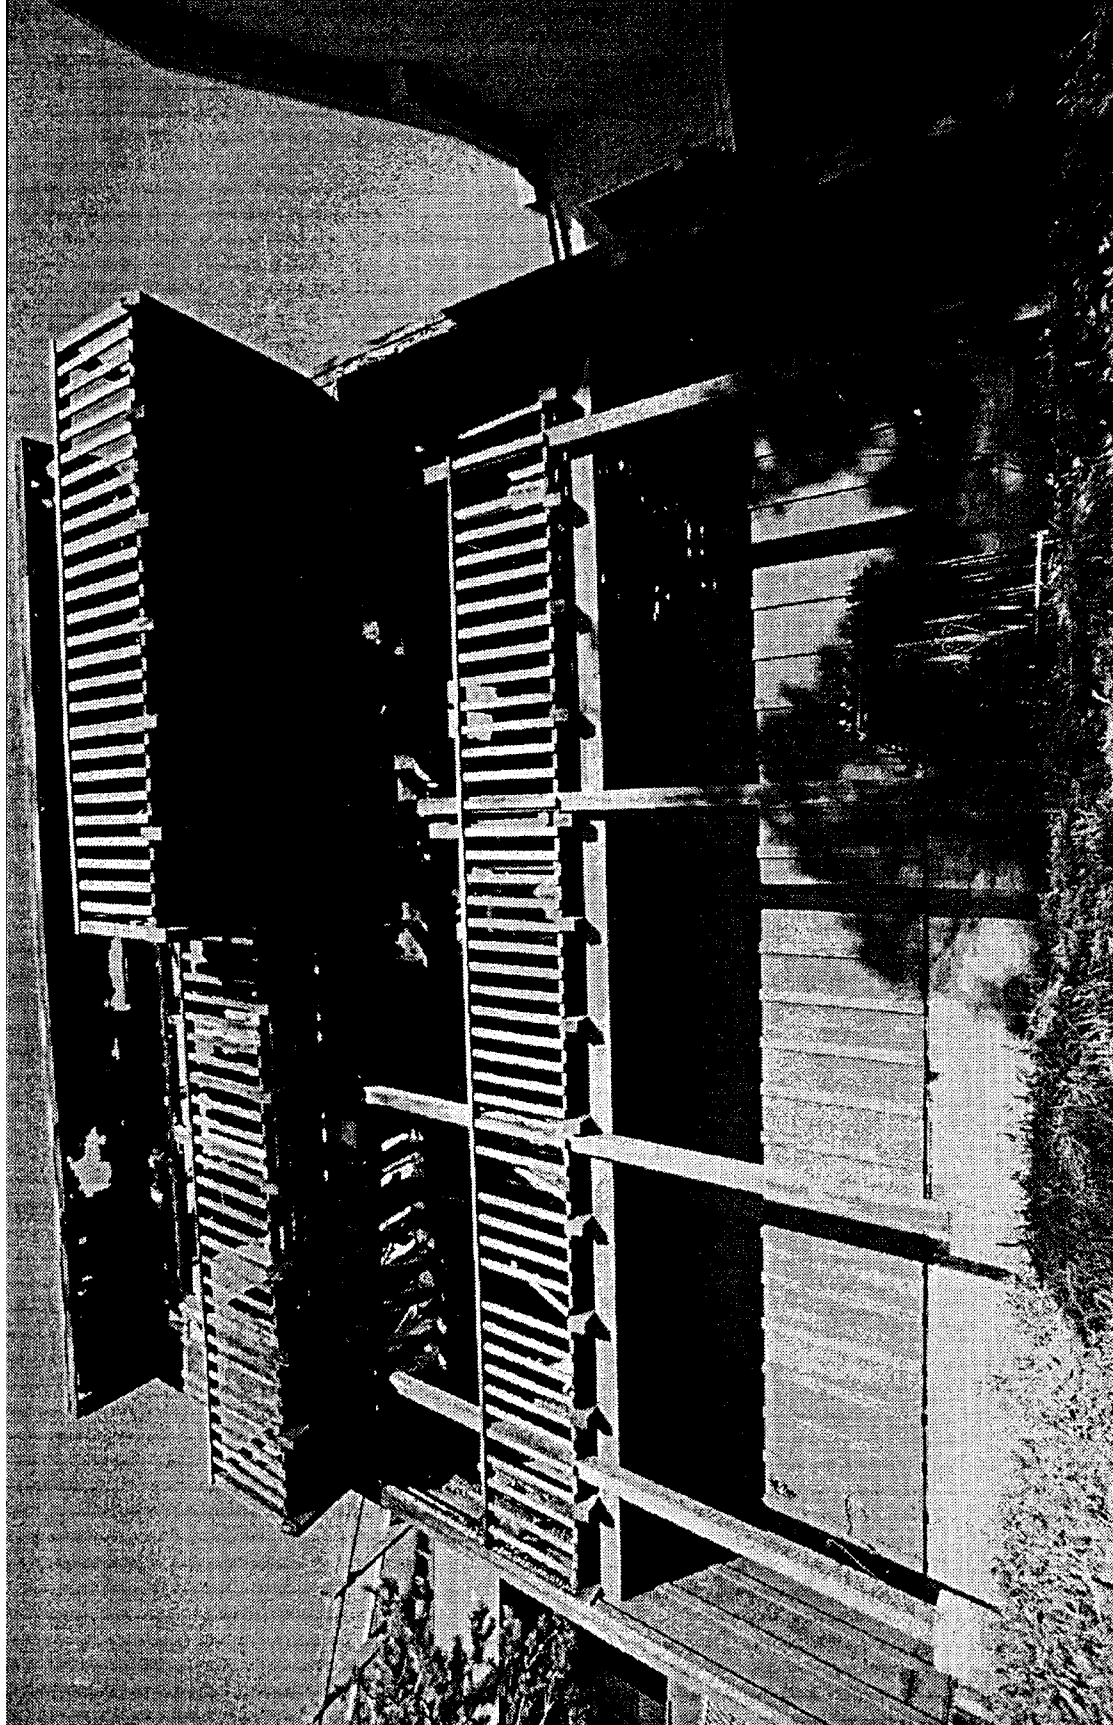
PHOTOGRAPH 2: The rear of the house as viewed from ground level. The fire started in the wall above the lower deck to the right center of the photograph.

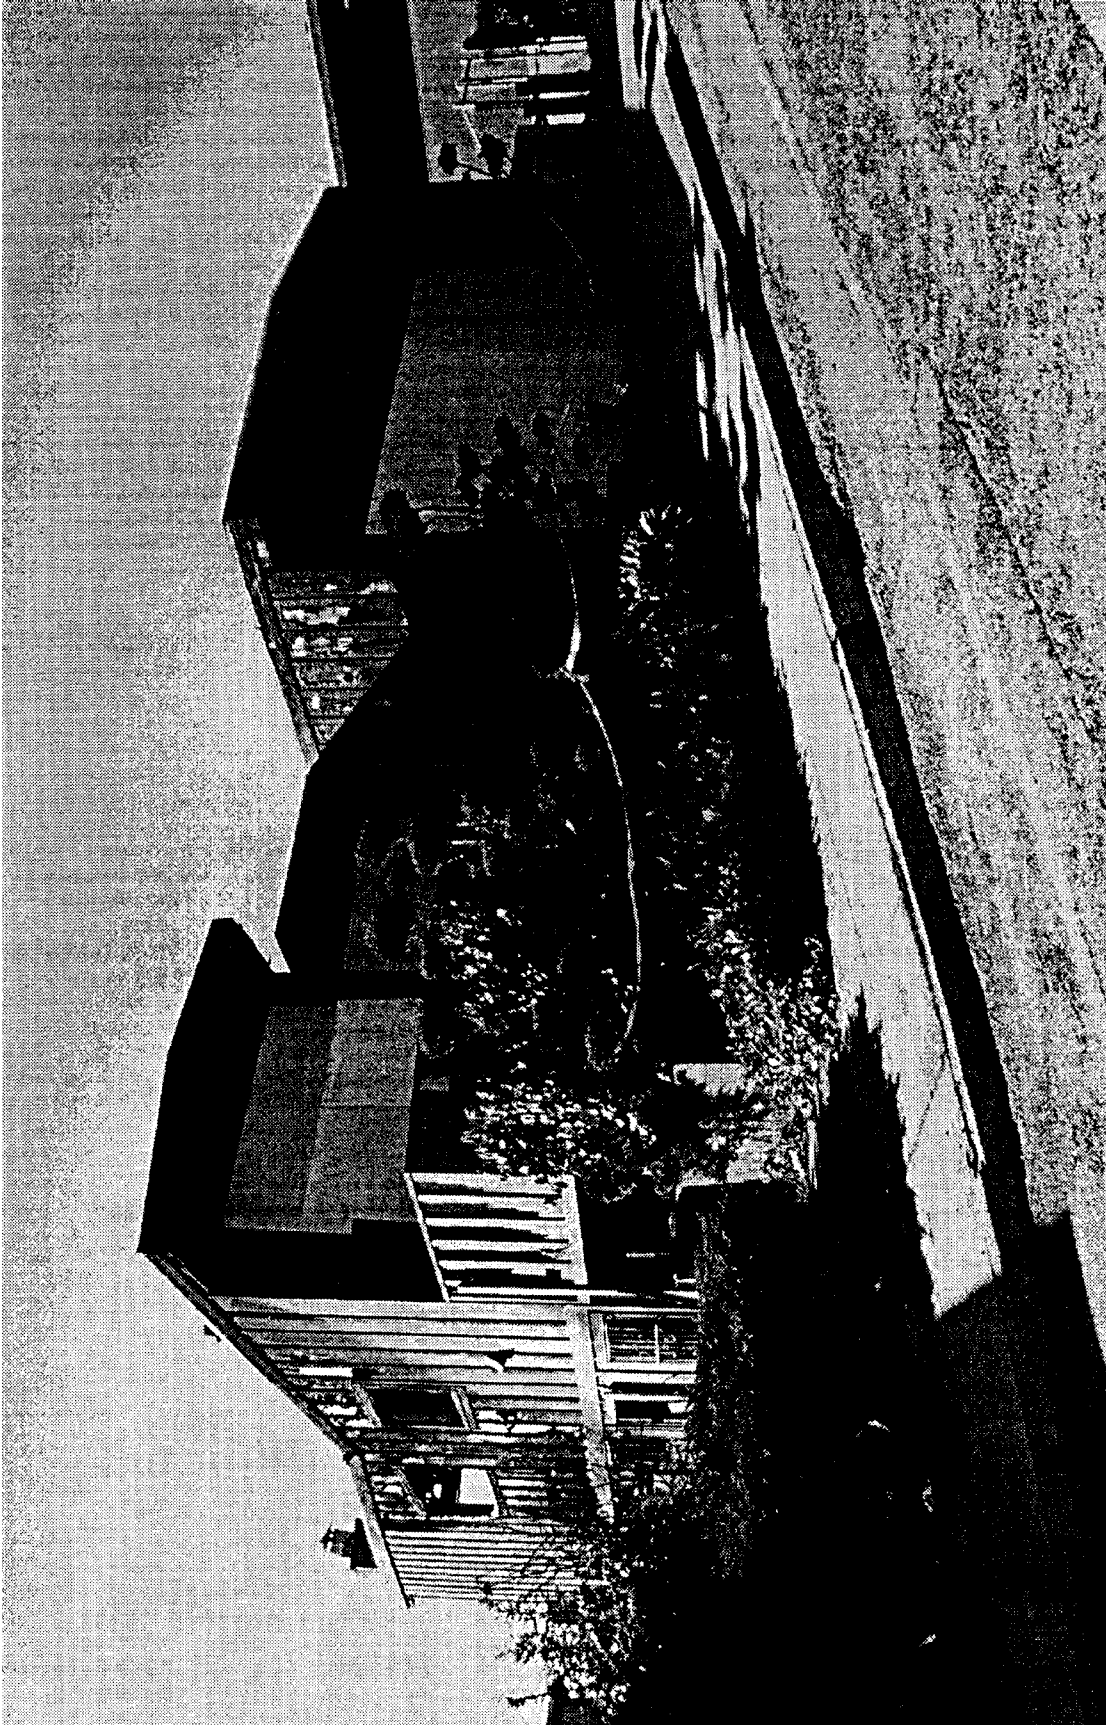
PHOTOGRAPH 3: The northeast corner of the house. Note the security gates on the lower level openings.

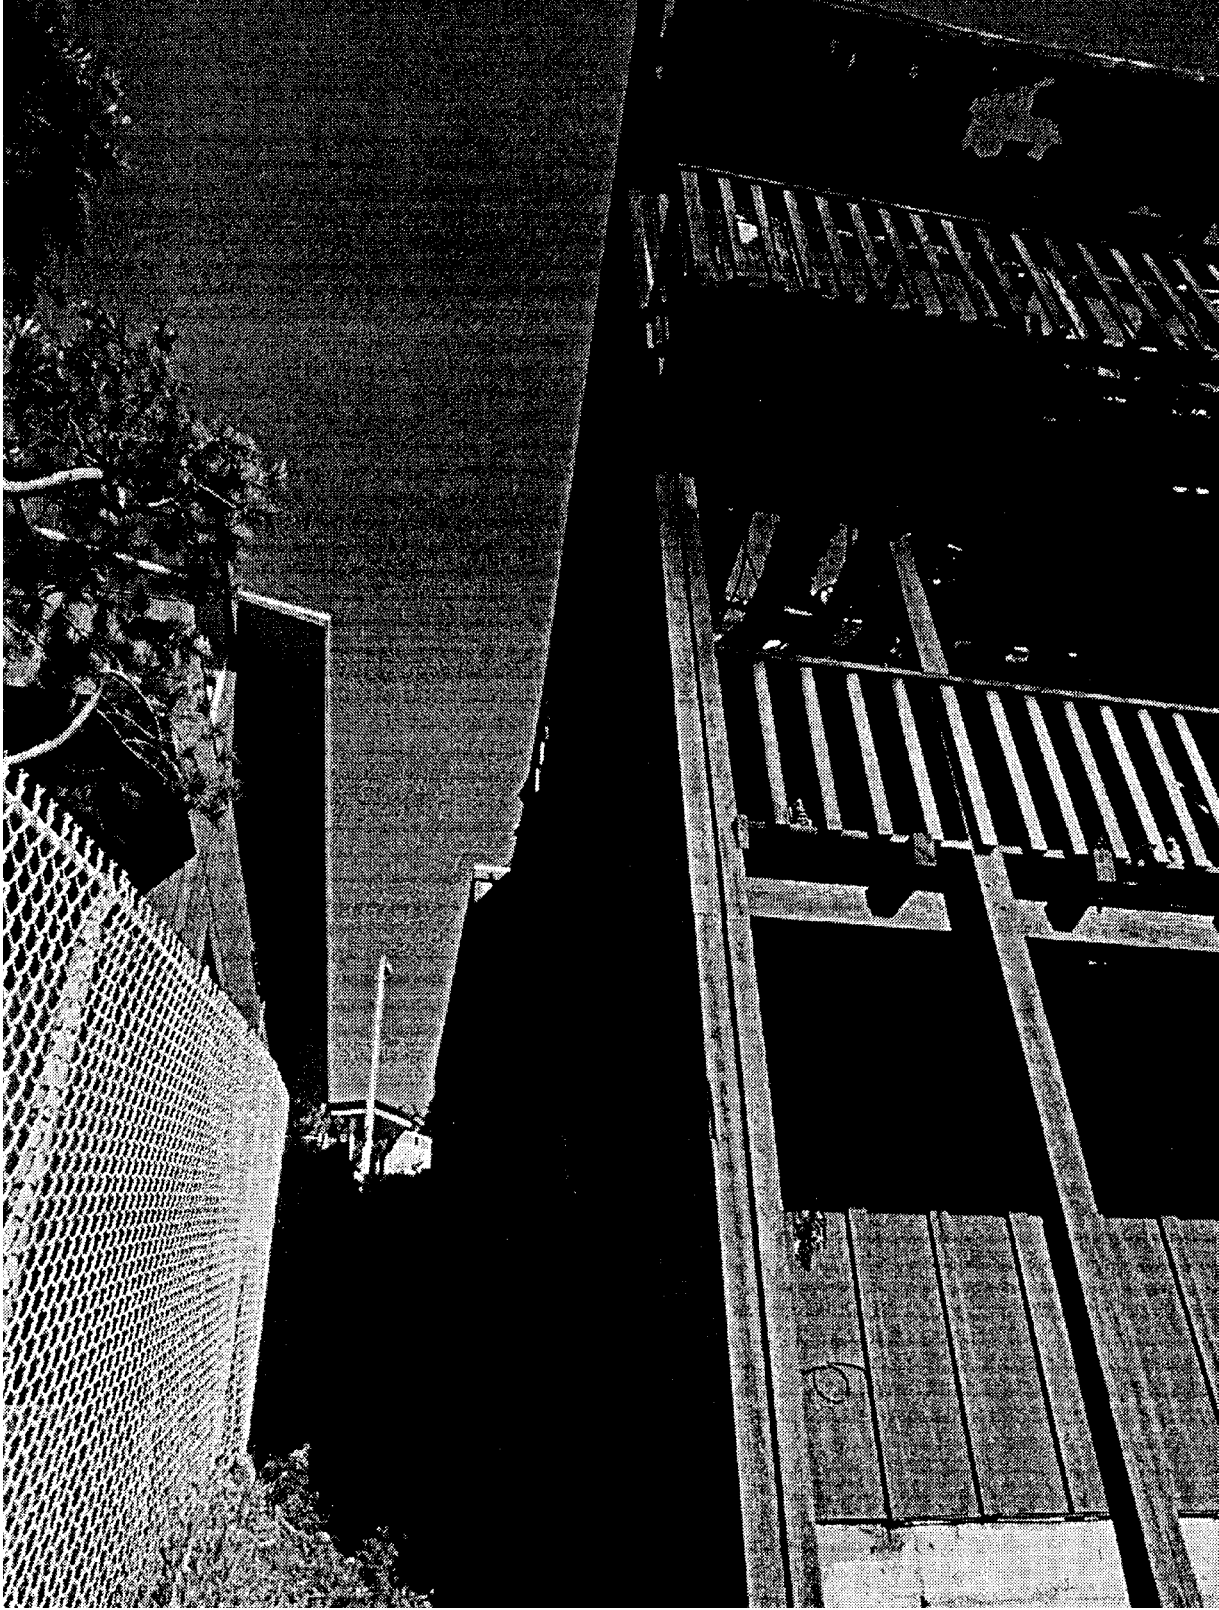
PHOTOGRAPH 4: The southwest corner of the house. Note the steepness of the building lot and the proximity of the house next door.
