Entrapment in Garage Kills One Firefighter

San Francisco, California

USFA-TR-084/March 1995

**75 Everson Street
San Francisco, California**

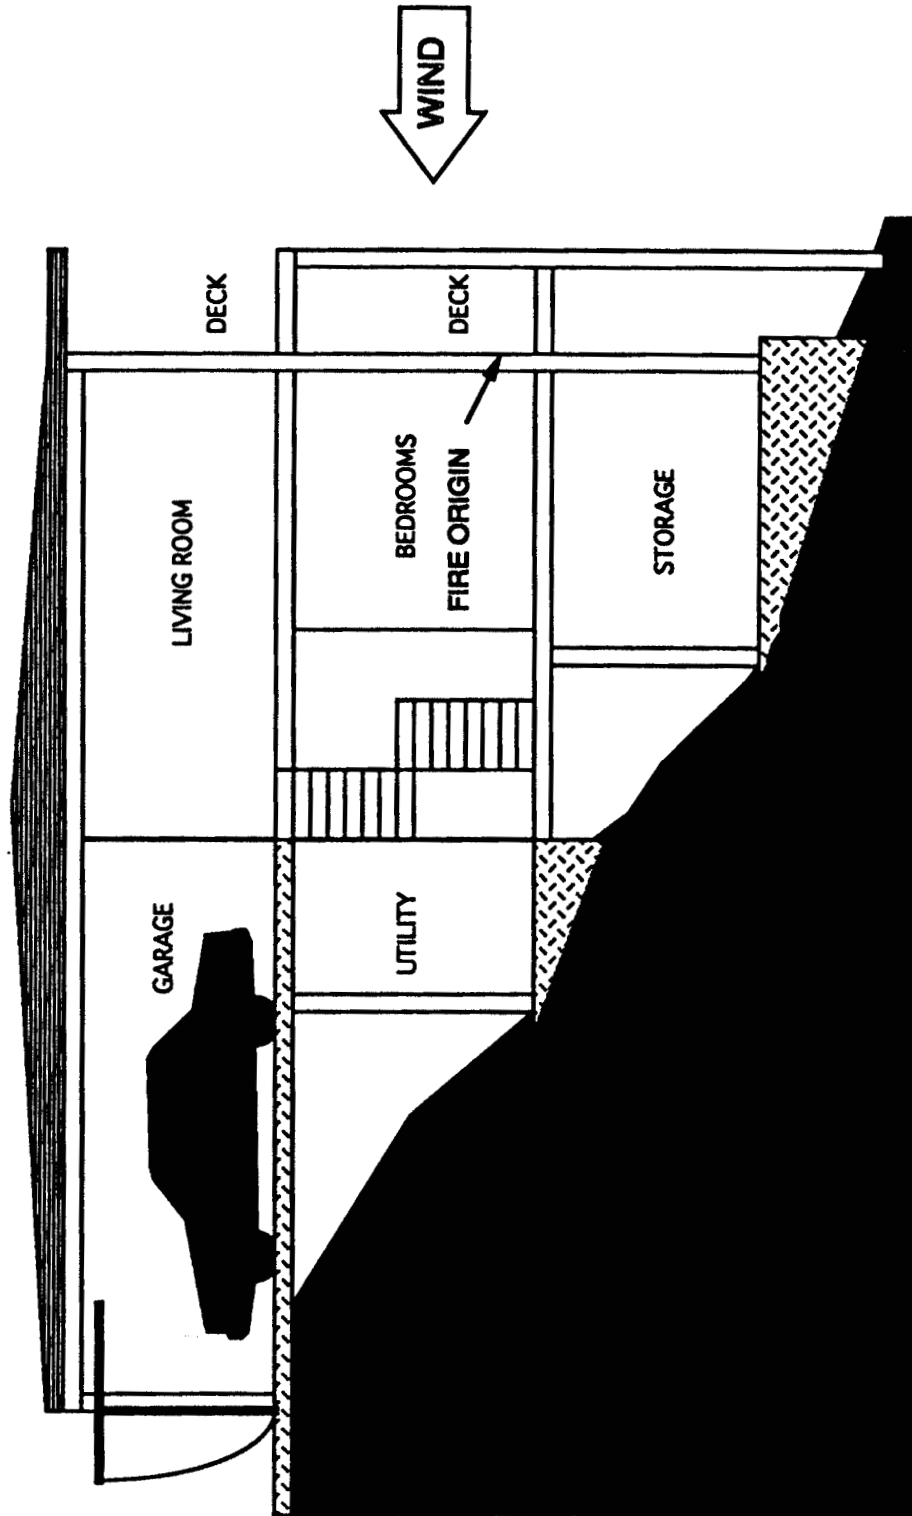
Figure 1a

The house had three levels (see Figures 1a and b). The lower level was only accessible from the back yard and was used exclusively for storage. The middle level had three bedrooms, each with a view to the south. A utility room ran the width of the house on the north side. Two full bathrooms flanked the open center stairway (Figure 3).
